Operating Experience Summary

Office of Nuclear and Facility Safety

March 11 — March 27, 2000

Summary 2000-06

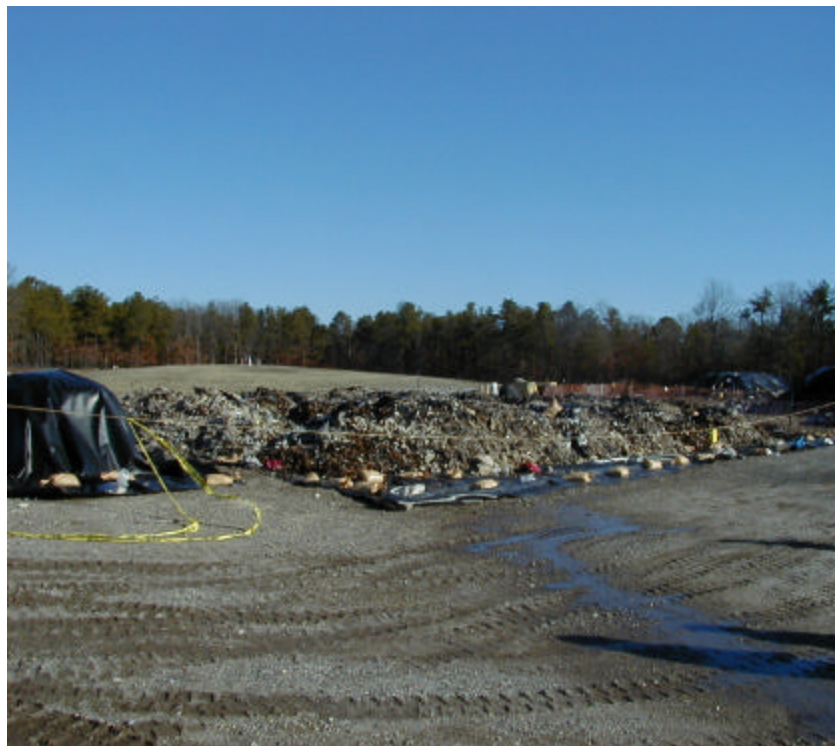
Figure 1-1. Overall view of waste pit area

Figure 1-1 provides an overall view of the waste pit area. Investigators determined that the fire started in one of the 32 supersacks filled with soil and shredded debris. A super sack is a waste container with a water-resistant outer covering and two layers of poly fabric. They determined that the waste filled supersacks were awaiting final characterization and shipment to an off-site disposal facility. Investigators also determined that the excavation pit waste was considered low level and although there was a history of pyrophorics and other hazardous materials present in the pit area, those materials should have been removed during the sorting and shredding operation. Investigators determined that organic rather than pyrophoric material located around the waste pit area was the most likely contributor to the combustion rate factor and that the fire started when temperatures exceeded 100 degrees Fahrenheit under the black poly-vinyl chloride sheet that covered the waste. They also determined that a waste-containing supersack, a polyurethane liner, and shredded personnel protective equipment were the main sources of combustion fuel. Investigators took infrared pictures of the waste material to identify possible heat sources, yet the results were inconclusive. They also determined that even though the waste contained low levels of Americium, Cesium, Thorium and Uranium it did not get hot enough to contribute to contamination spread.

A similar event took place at this facility in October 1999 during the shredding operation when a container encapsulating a sodium-potassium mixture was shredded and caused other combustible materials to ignite. (OPRS Report CH-BH-BNL-BNL-1999-0020). Although fire investigators determined that the two events stem from different causes, corrective actions implemented in the October 1999 event do not appear to have solved the waste pit area combustion problem.
